# Safety Inspection Report

Annual Inspection

## Outdoor Gym Equipment

Bembridge Parish Council

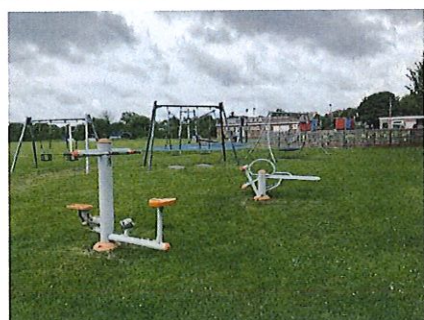
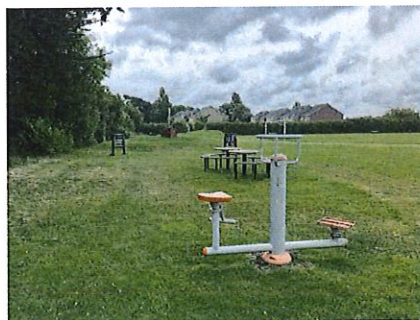
## Standard Compliance Finding

Fitness equipment has been installed in the immediate vicinity of children's playgrounds without being separated from general playing activities by an appropriate distance, fencing or other structural measures.

The equipment is positioned close to and between items of play equipment. Consider repositioning these items.

Medium

10

Relocate equipment.

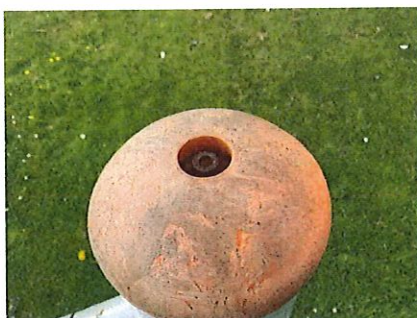
## Maintenance Finding

Cap missing.

Minor risk of accelerated corrosion.

Very low

1

Replace.

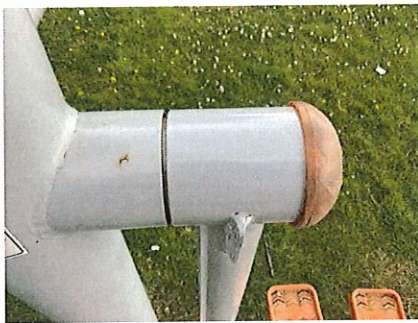
## Maintenance Finding

The supporting components should be dismantled and inspected according to the manufacturer's instructions. This will need doing on a regular basis, as defined by the manufacturer. This can lead to a high risk if no action is taken.

The noises produced from the equipment during use are not usual. The inspector is not able to determine the cause of this from external inspection. Dismantle and repair if appropriate.

Dismantle and inspect according to manufacturer's instructions.

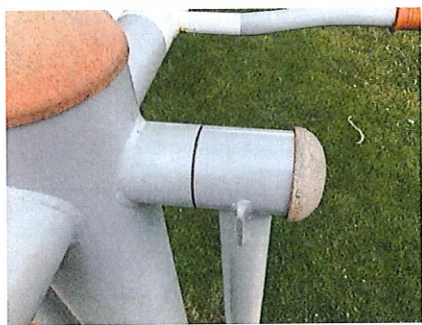
## Maintenance Finding

The supporting components should be dismantled and inspected according to the manufacturer's instructions. This will need doing on a regular basis, as defined by the manufacturer. This can lead to a high risk if no action is taken.

The noises produced from the equipment during use are not usual. The inspector is not able to determine the cause of this from external inspection. Dismantle and repair if appropriate.

Dismantle and inspect according to manufacturer's instructions.

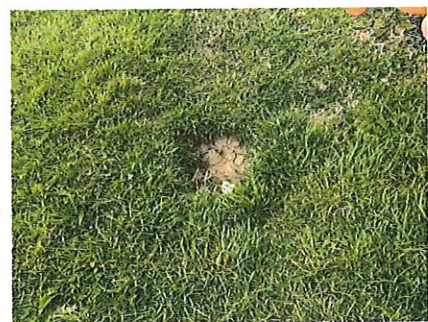
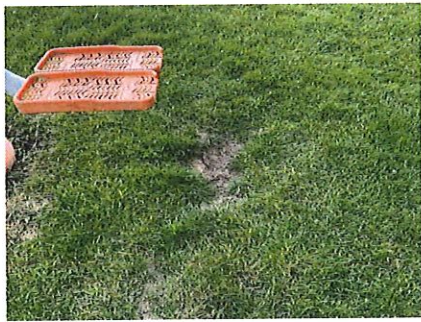
## Maintenance Finding

Surface is uneven.

Low

6

Make good.
